**Re: Phase I - Condition Assessment**  
**Kiley Garden Park Plaza Waterproofing Assessment**  
**Tampa, FL**  
**Walter P Moore Project No. D07.20021.00**

# KILEY GARDEN PARK PLAZA WATERPROOFING ASSESSMENT PHASE I - CONDITION ASSESSMENT

400 N. Ashley Drive  
Tampa, FL 33602

<b>Report Date</b>	July 30, 2021
<b>WPM Proposal No.</b>	19-3035
<b>WPM Project No.</b>	D07.20021.00

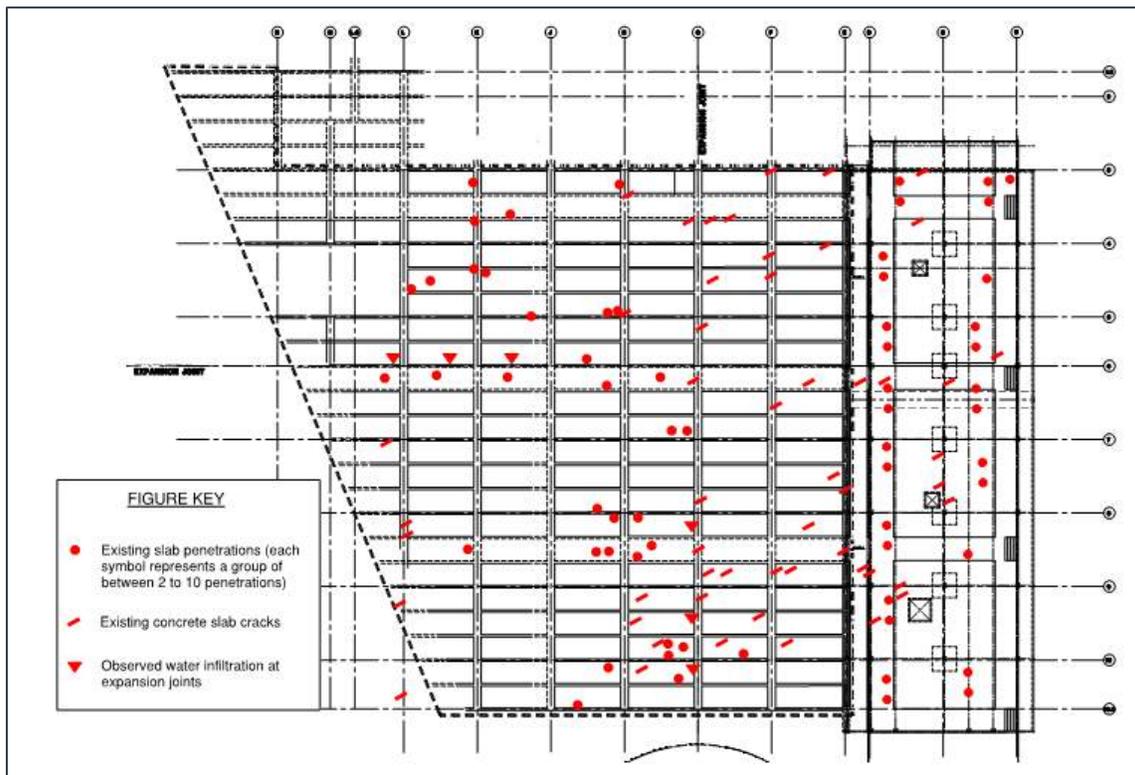
Figure 6: Observations of water infiltration at slab underside from parking garage Level B1

Water stains and active water infiltration were observed at the underside of the structural slab at cracks, construction joints, and penetrations from inside parking Level B1. Additionally, water infiltration through the structural slab has resulted in several locations of failed post-tensioned tendons, which has adversely affected the overall integrity of the parking garage structure. (A more detailed assessment of the failed post-tensioned tendons and associated repair recommendations is provided in our condition assessment report of the Rivergate Tower Parking Garage, dated August 18, 2017).

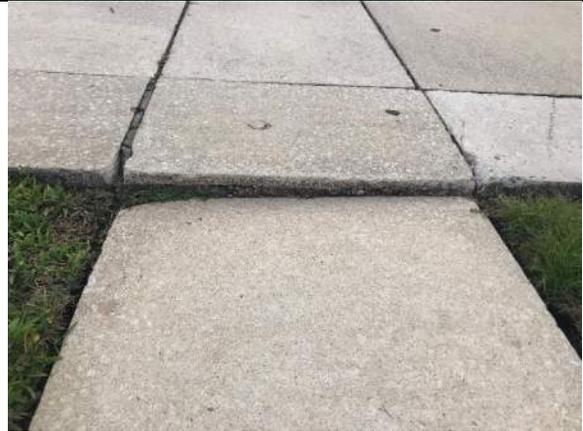
Photo	PLAZA SURFACE
8	Pavers on the Plaza Level walking surfaces were vertically displaced and settling at several locations. This condition creates trip hazards.
9	Cracked pavers were observed at multiple locations.  Standing water was observed adjacent to the amphitheater indicating inadequate drainage below.  Failed joint sealants were observed at the perimeter wall at the west side of the plaza.
Photo	WATERPROOFING: EXPLORATORY EXCAVATION OPENINGS
10, 11	<u>Exploratory Opening #1: Girder-to-topping slab transition</u>
12	<ul style="list-style-type: none"> <li>A blister filled with water, measuring approximately 6-inches x 6-inches, was observed in the sheet waterproofing membrane on the top, horizontal surface of the upturned girder.</li> <li>Sheet waterproofing membrane on the topping slab appeared to be well-bonded at the area observed.</li> </ul>
13	<ul style="list-style-type: none"> <li>A sample of the sheet waterproofing membrane measuring approximately 3-inches by 3-inches was taken. The membrane was observed to be brittle.</li> </ul>

**8** Concrete paver settlement

The Americans with Disabilities Act (ADA) standards state that that “changes in level of ¼-inch high maximum shall be permitted to be vertical.” The vertically displaced pavers observed at the plaza level have created sudden changes in elevation of more than ½-inch at several locations. These conditions represent potential trip hazards for pedestrians using the park facilities. We recommend that these pavers be re-leveled or replaced in order to restore the walking surface to be ADA-compliant.

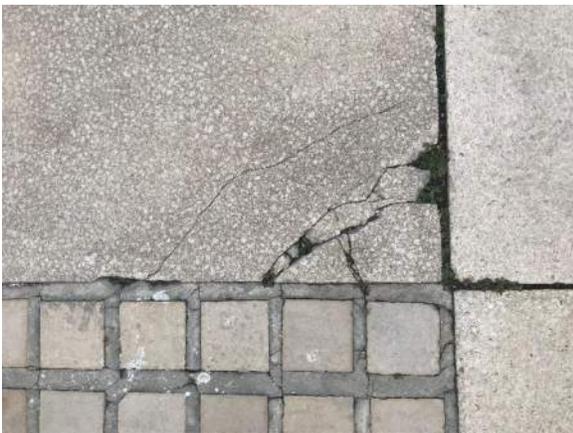
**9** Concrete paver cracks

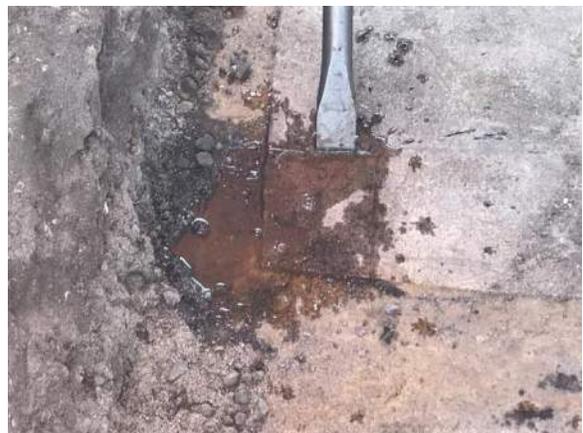
**12** Water under membrane at blister

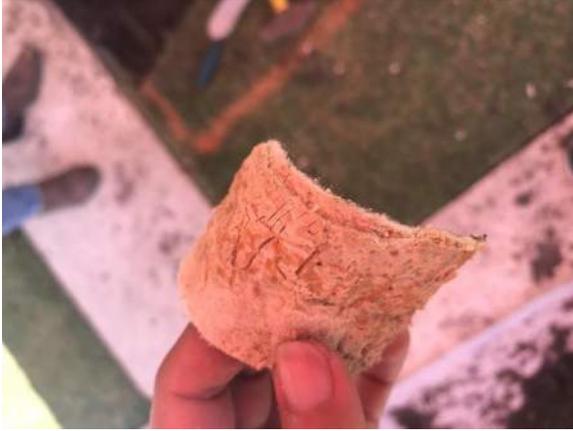
**13** Sample of sheet waterproofing membrane

Samples of the existing sheet waterproofing were taken on-site during exploratory work, and the material was observed to be brittle. A waterproofing membrane should be flexible in order to accommodate movement of the concrete structure due to thermal changes, loading, etc. *The joint between the 3-inch topping slabs installed during the 2008 renovation project and adjoining beams and girders is particularly susceptible to movement and tearing of the waterproofing membrane which has occurred throughout the plaza.* A brittle material has an increased potential to crack and allow water infiltration below the membrane. Since drains are only installed at the topping slab level within the abandoned planter cells, it is imperative that the waterproofing membrane that is installed on the topping slab be watertight.

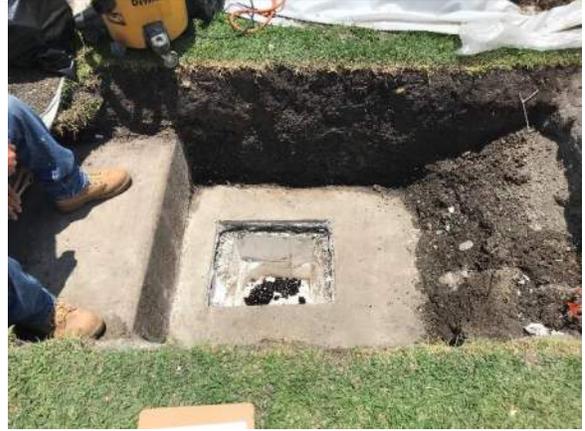
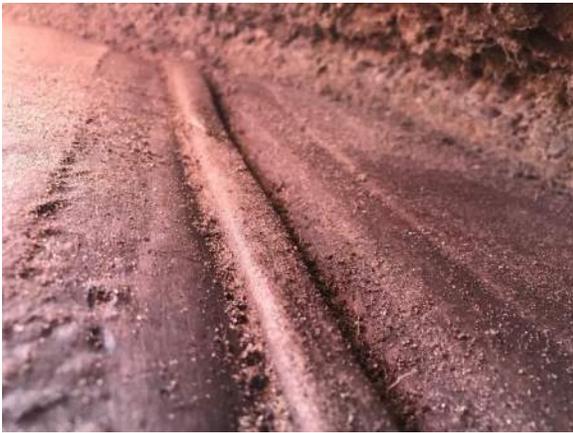
14	<u>Exploratory Opening #2: Expansion joint, girder-to-topping slab transition, foam fill, and structural slab surface</u>
15	<ul style="list-style-type: none"> <li>No distress was observed at the existing expansion joint material.</li> <li>The sheet waterproofing membrane on the topping slab and girder appeared to be well-bonded at surface area observed.</li> </ul>
16	<ul style="list-style-type: none"> <li>Water stains were observed on the foam fill below the topping slab.</li> </ul>
17, 18	<ul style="list-style-type: none"> <li>Approximately 4 inches of standing water were observed on the structural slab, at the bottom of the foam fill. This observation was reported by the Contractor.</li> <li>An apparent asphaltic waterproofing membrane was observed on the surface of the structural slab. The membrane appeared to be well-bonded at the area observed.</li> </ul>
19, 20	<u>Exploratory Opening #3: Beam-to-topping slab transition</u>

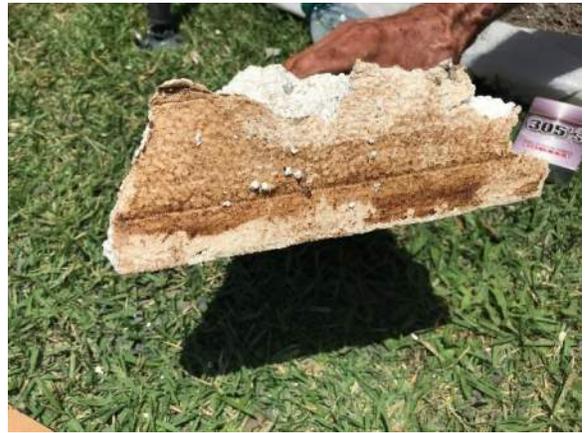
**16** Water stains on foam fill under topping slab

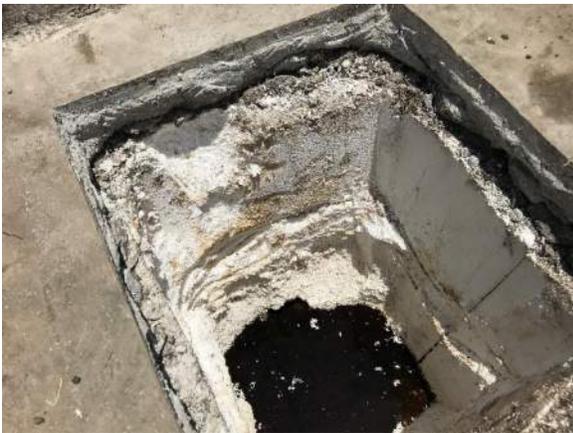
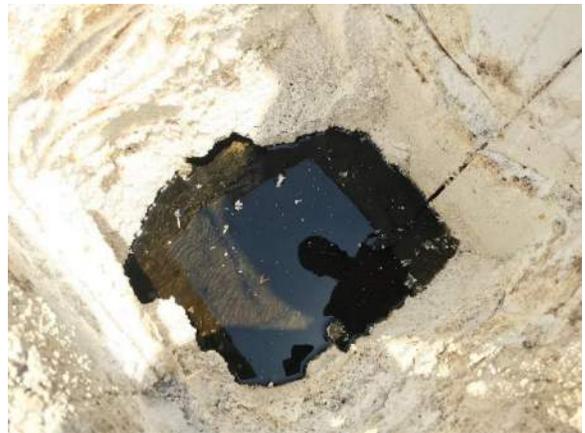
**17** Standing water on structural slab

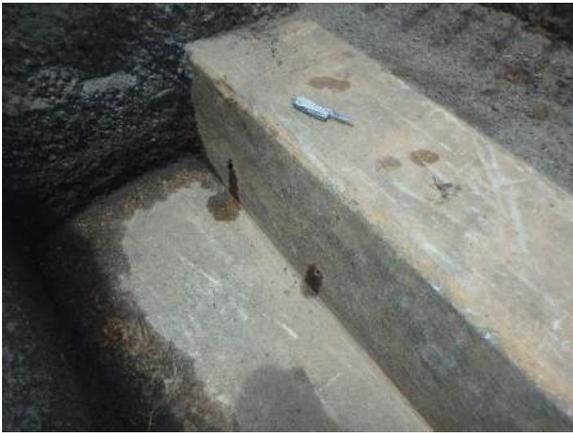
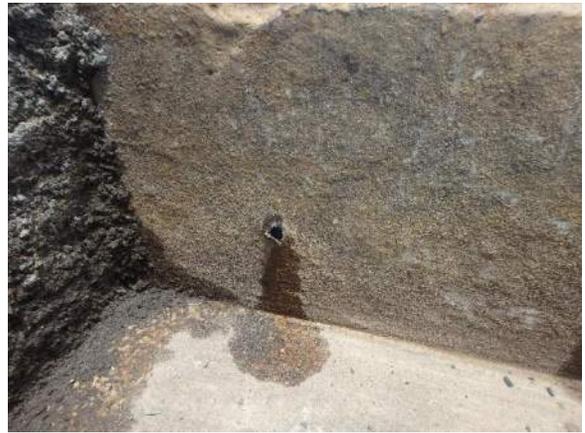
<ul style="list-style-type: none"> <li>Sheet waterproofing membrane on the topping slab appeared to be well-bonded at most of the area observed.</li> </ul>
21, 22	<ul style="list-style-type: none"> <li>Small blisters filled with water were observed on the vertical face of the upturned beam.</li> </ul>
23, 24	<u>Exploratory Opening #4: Topping slab surface, foam fill, and structural slab surface</u>
25	<ul style="list-style-type: none"> <li>Sheet waterproofing membrane on the topping slab was de-bonded throughout the area observed, though no apparent breaches in the membrane were observed.</li> <li>No water staining or visible signs of distress were observed on the foam fill.</li> </ul>

**21** Water found behind membrane

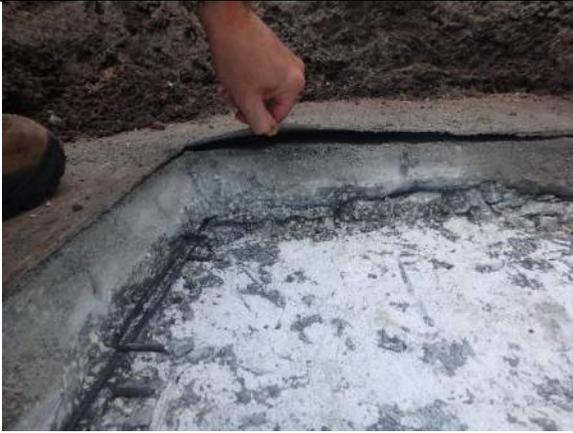
**25** Waterproofing membrane de-bonded at topping slab

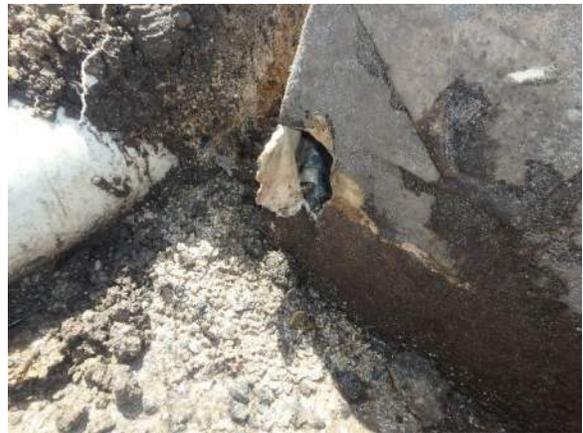
**30** Water observed behind waterproofing membrane

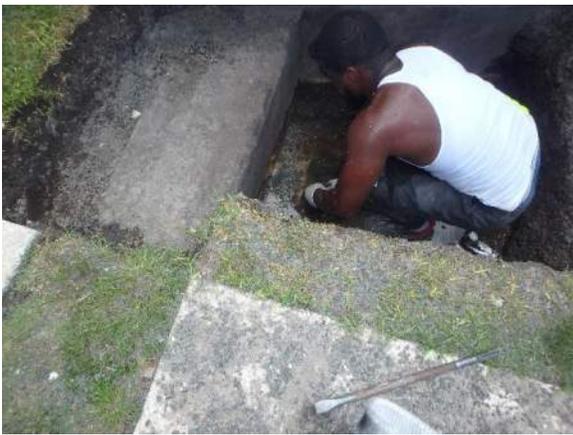
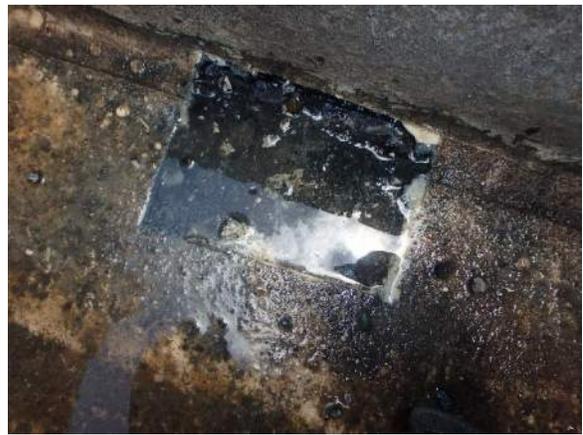
31, 33	<u>Exploratory Opening #7:</u> Perimeter wall beam-to-topping slab transition.	
33, 34		<ul style="list-style-type: none"> <li>• A crack in the sheet waterproofing membrane was observed at the transition between the vertical face of the beam and the topping slab. Water was observed leaching out through the crack.</li> <li>• Upon puncturing the sheet waterproofing membrane on the vertical wall surface with a knife, moisture was observed below the membrane.</li> </ul>
35, 36	<u>Exploratory Opening #8:</u> Amphitheater wall-to-topping slab transition.	<ul style="list-style-type: none"> <li>• Sheet waterproofing membrane on the topping slab and wall appeared to be well-bonded at the area observed.</li> </ul>
37, 38	<u>Exploratory Opening #9:</u> Expansion joint, top of girder.	<ul style="list-style-type: none"> <li>• No visible distress was observed at the existing expansion joint.</li> <li>• The sheet waterproofing membrane on the top side of the girder appeared to be well-bonded at the area observed.</li> </ul>

**34** Water found under membrane at sample removal location

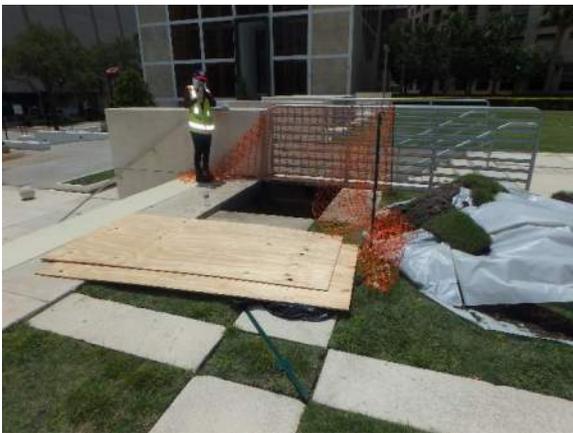
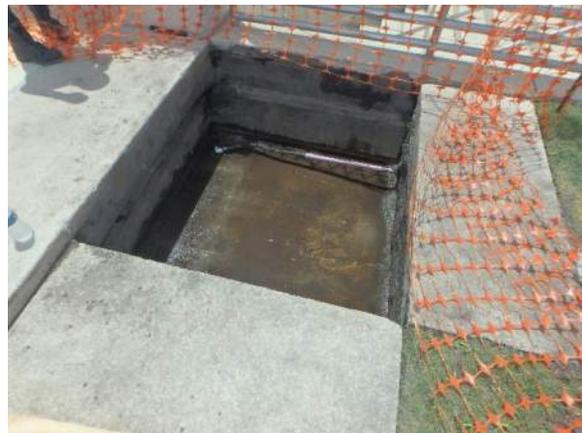
39, 40	<u>Exploratory Opening #10:</u> Stair wall-to-topping slab transition.	<ul style="list-style-type: none"> <li>• The sheet waterproofing membrane on the vertical wall surface terminated below the paver level.</li> <li>• Moisture was observed within the gap between the concrete beam and paver setting bed.</li> </ul>
41, 42		<ul style="list-style-type: none"> <li>• Upon puncturing the sheet waterproofing membrane on the topping slab/vertical wall surface with a knife, moisture was observed below the membrane.</li> </ul>
43, 44	<u>Exploratory Opening #11:</u> Topping slab surface.	<ul style="list-style-type: none"> <li>• The sheet waterproofing membrane on the topping slab appeared to be well-bonded at the area observed.</li> </ul>

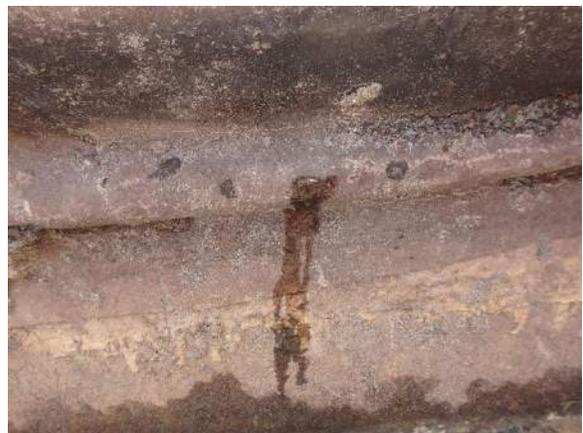
42 Water observed behind membrane at puncture

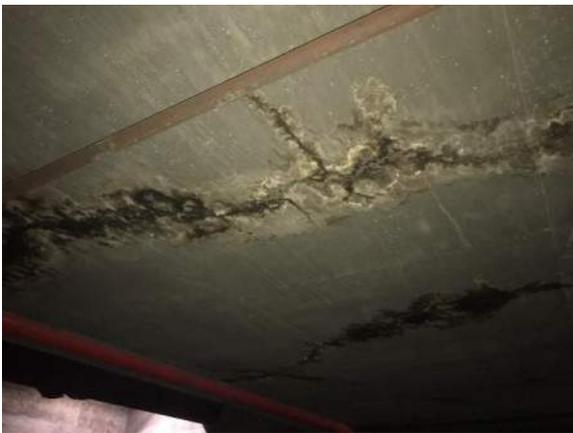
- 45 Concrete cracks were observed at the underside of slabs with efflorescence staining at multiple locations.  
Water stains were observed at construction joints in the overhead planter cell walls at multiple locations.  
Active water infiltration was observed at expansion joints at multiple locations.

**45** Crack with water staining at underside of Plaza Deck

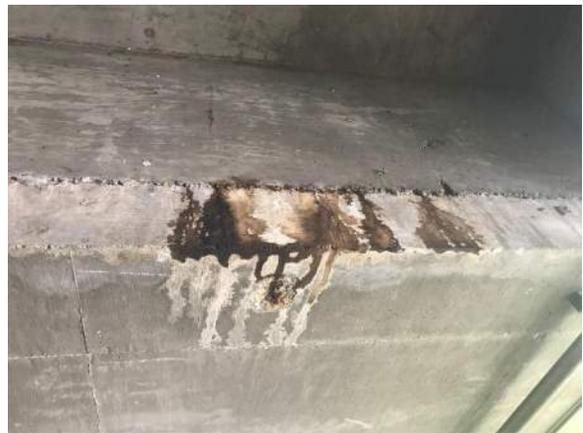
**46** Water stains, underside of Plaza Deck

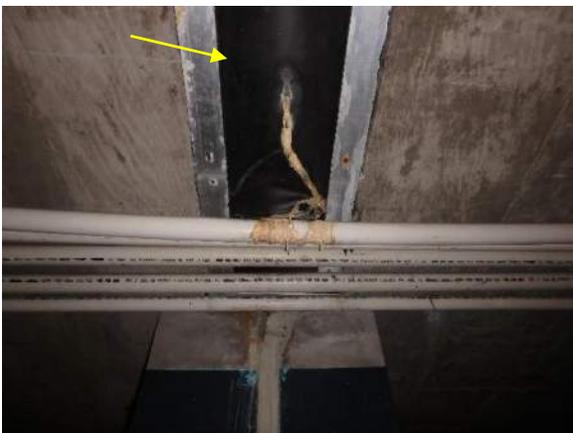
- 47 Supplemental, retrofit gutters comprised of a flexible sheet membrane were observed under expansion joints.
- 48 Retrofit drip pans were installed at the underside of the Plaza Level slab at multiple locations throughout the garage under slab penetrations, cracks and joints that exhibited evidence of past water infiltration.

**47** Remedial gutter below Plaza Deck expansion joint

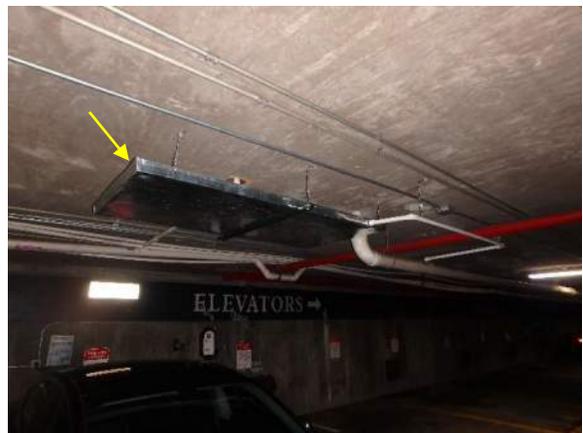
**48** Drip pan below Plaza Deck

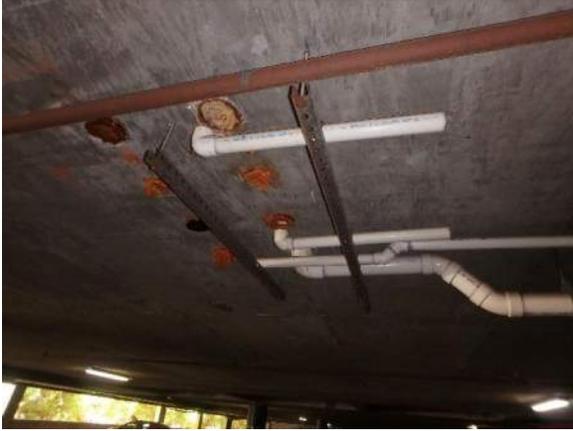
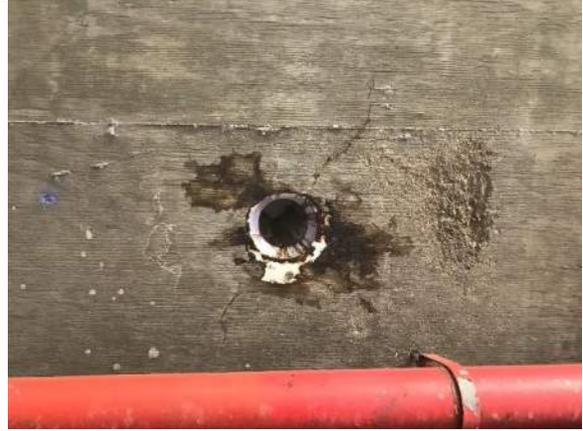
- 49, 50 Active water infiltration was observed at existing and abandoned penetrations through the plaza slab at multiple locations.  
Injection ports remaining from past epoxy or chemical injection work were observed at the underside of the slab in an area below the lower Plaza Level.

**49** Group of abandoned penetrations through Plaza Deck slab

**50** Water stains at abandoned penetration

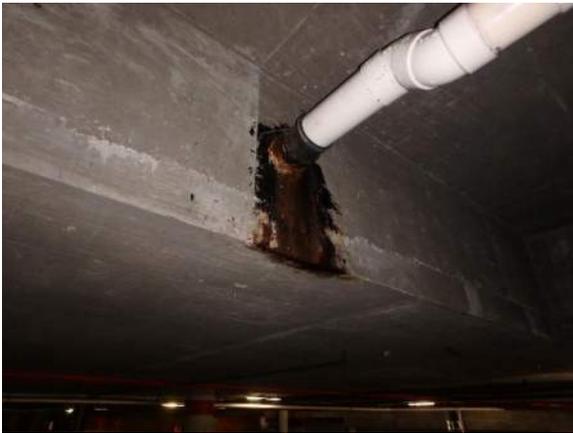
- 51 Water stains were observed at penetrations of polyvinyl chloride (PVC) lateral drain pipes through planter cell walls at multiple locations.
- 52, 53 Water stains and active water infiltration at the east and north foundation walls were observed at wall cracks and wall penetrations.

**51** Water stains at pipe penetration through abandoned planter cell

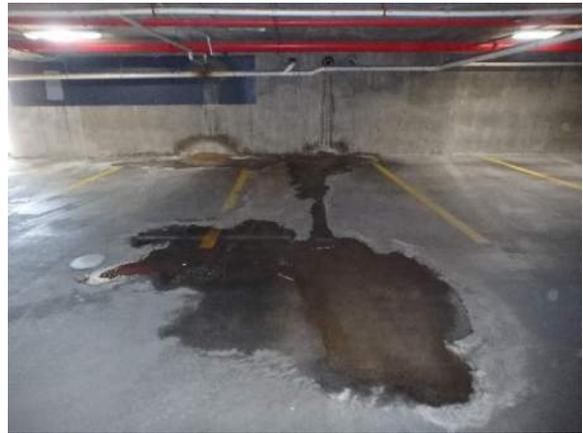
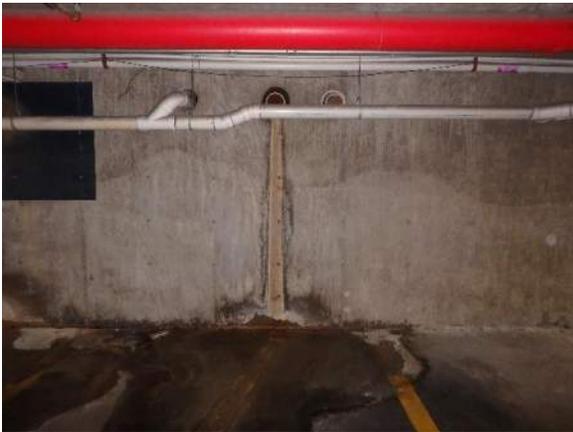
**52** Water infiltration at north foundation wall (see following photo)

11. Perform chemical injection of cracks and penetrations at east and north foundation walls.

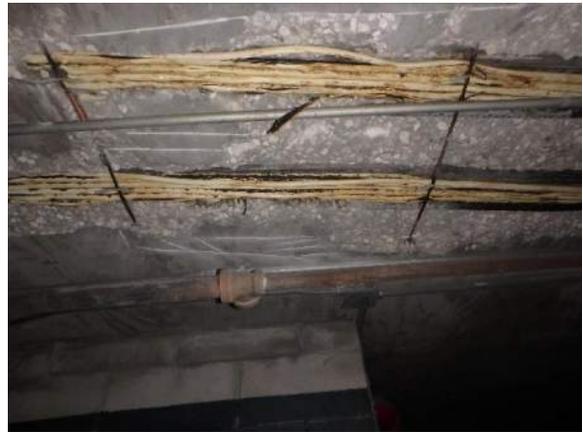
- 54 Failed post-tensioned tendons were observed at the plaza level structural slab from inside the parking garage at Level B1 below Area B.  
Isolated concrete spalling was observed at the underside of the Plaza Level slab from inside the parking garage.  
Isolated concrete repairs were observed at the underside of the Plaza Level slab.

**54** Failed post-tensioned tendons at Plaza Deck slab

1. Retain a qualified plumbing engineer to investigate feasible options and associated probable construction costs for a new drainage system for the planter cells in which drains are provided at the lowest point of the planter cells (structural slab level).
2. Complete predesign and repair of the failed post-tensioned slab indicated in previous condition assessment reports.

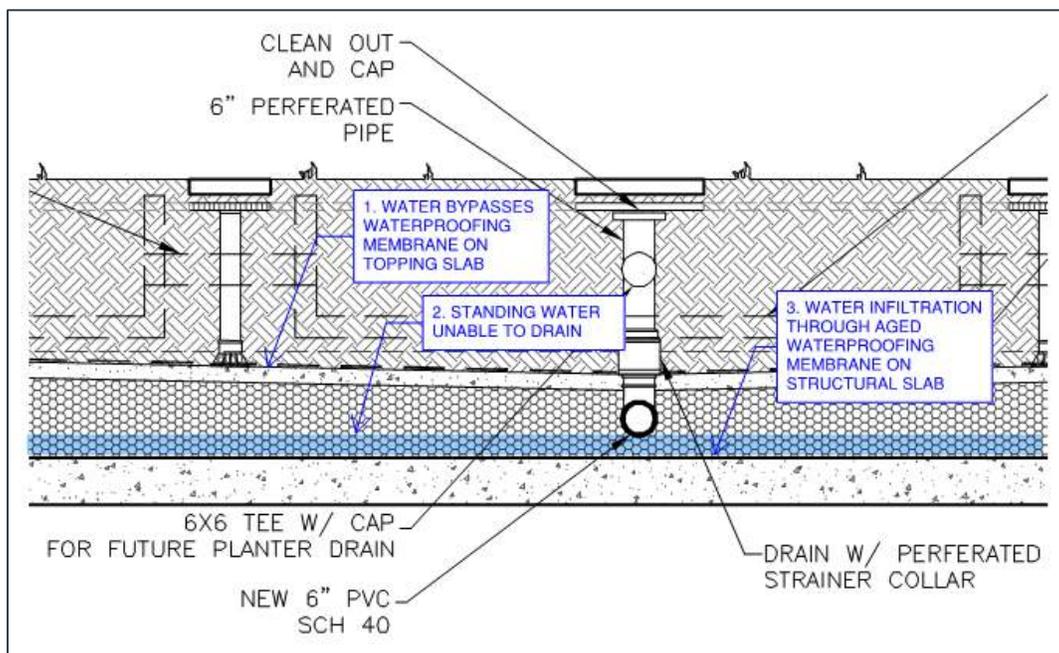
Figure 7: Current condition – inadequate drainage within planter cells at Plaza Level above parking garage

Drains within the abandoned planter cells are currently only located at the level of the topping slabs installed in 2008. There are no drains at the structural slab level below. The water that breaches and passes through the waterproofing at membrane defects collects at the bottom of the cells (see Figure 7 below). This was evidenced by the observation of water-stained foam fill below the topping slab, and standing water on top of the lower structural slab within the planter cells. With no drains at the structural slab level, the water which collects at the bottom of the cells will infiltrate slab cracks, construction joints, transition joints, and penetrations in the structural slab over time and pass into the parking garage below.
